Timber Framed Buildings in Wantage

by John Garnish

Grove Street, Wantage

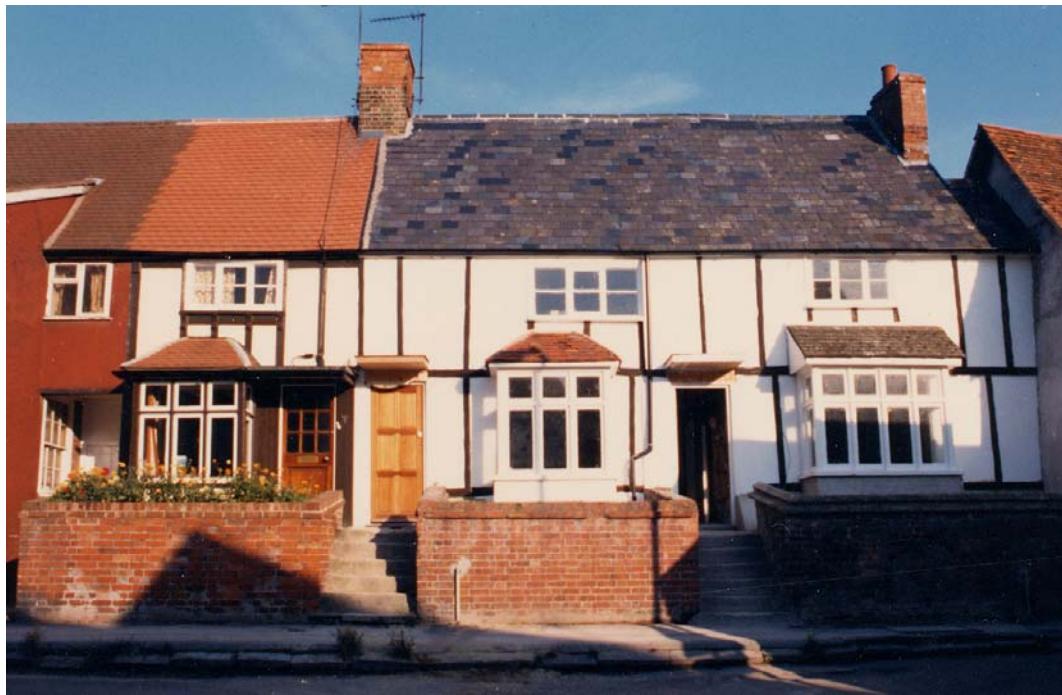
Nos. 36

34

32

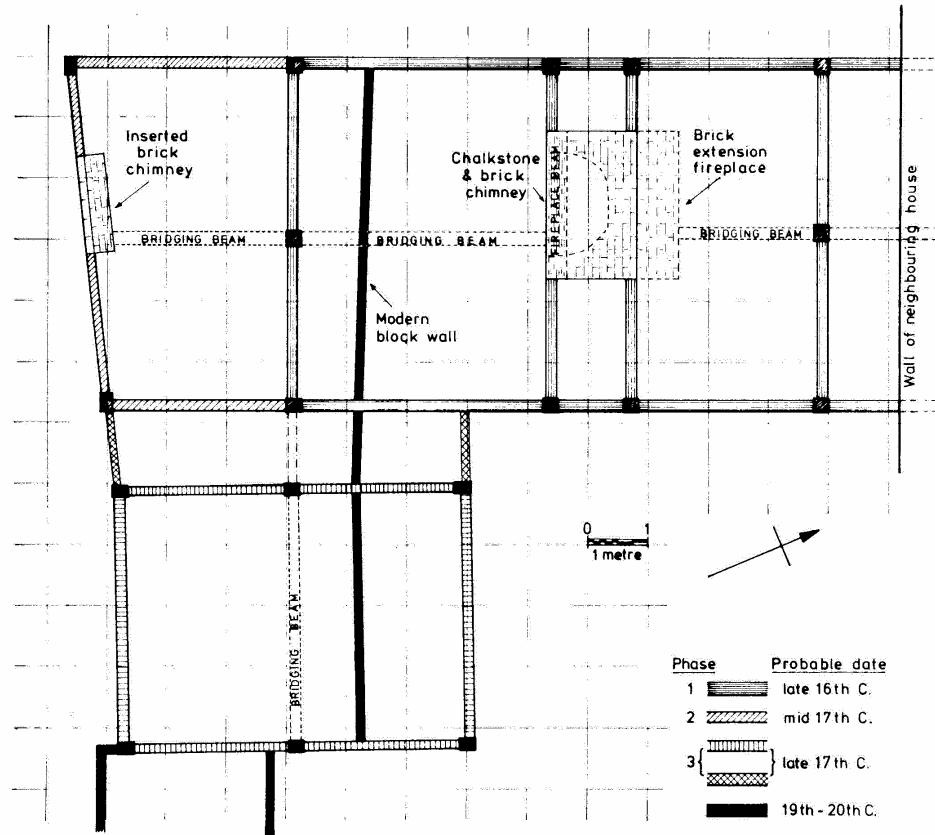
dimensions and quality of the major structural timbers. The ground plan is shown in Figure 1, on which I have also imposed an indication of my estimate of the dates of the main phases of building. The building has undergone many alterations during its lifetime, some of them fairly horrific in their disregard for - or ignorance of - the basic integrity of the structure, but the major stages of development proved fairly easy to disentangle. In view of all the alterations that have taken place over the years, and the inaccessibility of parts of the building, the perspective drawings of the structure which illustrate this note are somewhat idealized but represent a best estimate of the main characteristics prior to the Victorian facelift. The complete assembly is shown in Figure 2.

Figure 1. *Ground plan and possible dates of structure*

It seems likely, therefore, that this was an outbuilding or barn used for storage rather than living accommodation. The fact that it stands only 4 feet from the window in Phase 2 (see Figures 1 and 6), and completely obscures any view that it might have had, suggests that it post-dates Phase 2 by a substantial period - probably at least 50 years.

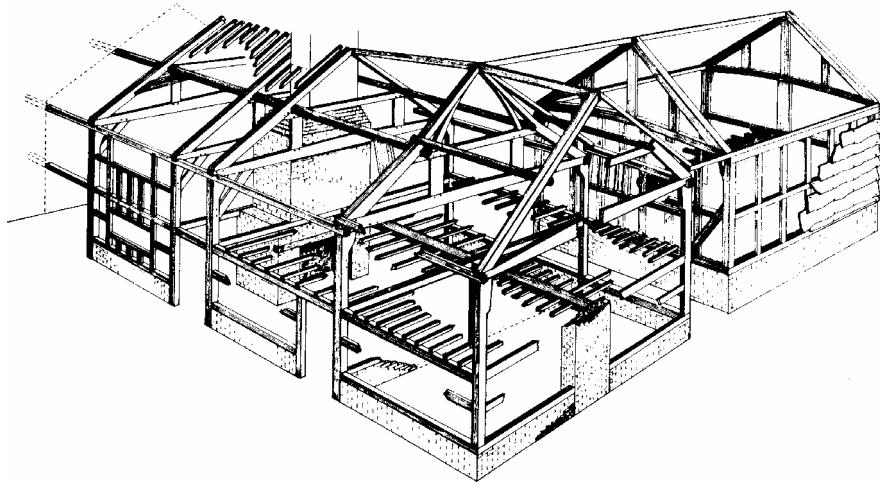
Figure 2. Perspective view (looking north-east from Grove Street)

The surviving common rafters are 4" square, halved or tenoned together at the ridge. There is no ridge timber (see Figure 2).

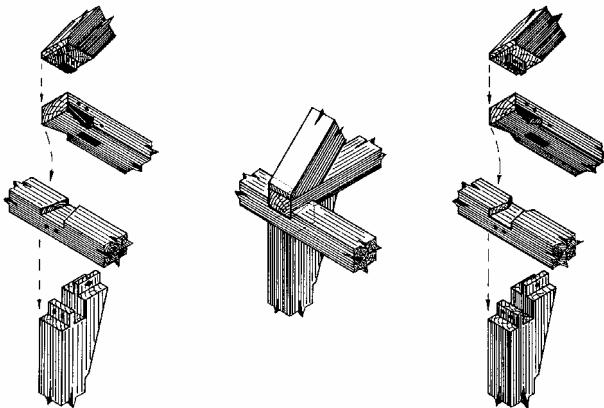
The main wall posts consist of 9" square oak timbers with sawn jowls at the upper end to accommodate the junction with wall-plate and tie beam. The joint between wall-post, tie-beam and wall plate is of the normal lap dovetail and jowl tenon type -see Figure 3a.

*Figure 3 Wall post / tiebeam / principal rafter joint
(a) normal single dovetail (b) twin dovetail*

The corner joint is of an unusual pattern with a double dovetail (Figure 3b); it was visible because the western wall-plate had been replaced - presumably when the roof-line was changed - with a thinner plate which left the dovetail exposed on the tie-beam (and significantly weakened the structure'). The original eastern wall-plate does still remain, and is notched along its upper edge to take the common rafters. These notches would take 4" rafters at 15" intervals.

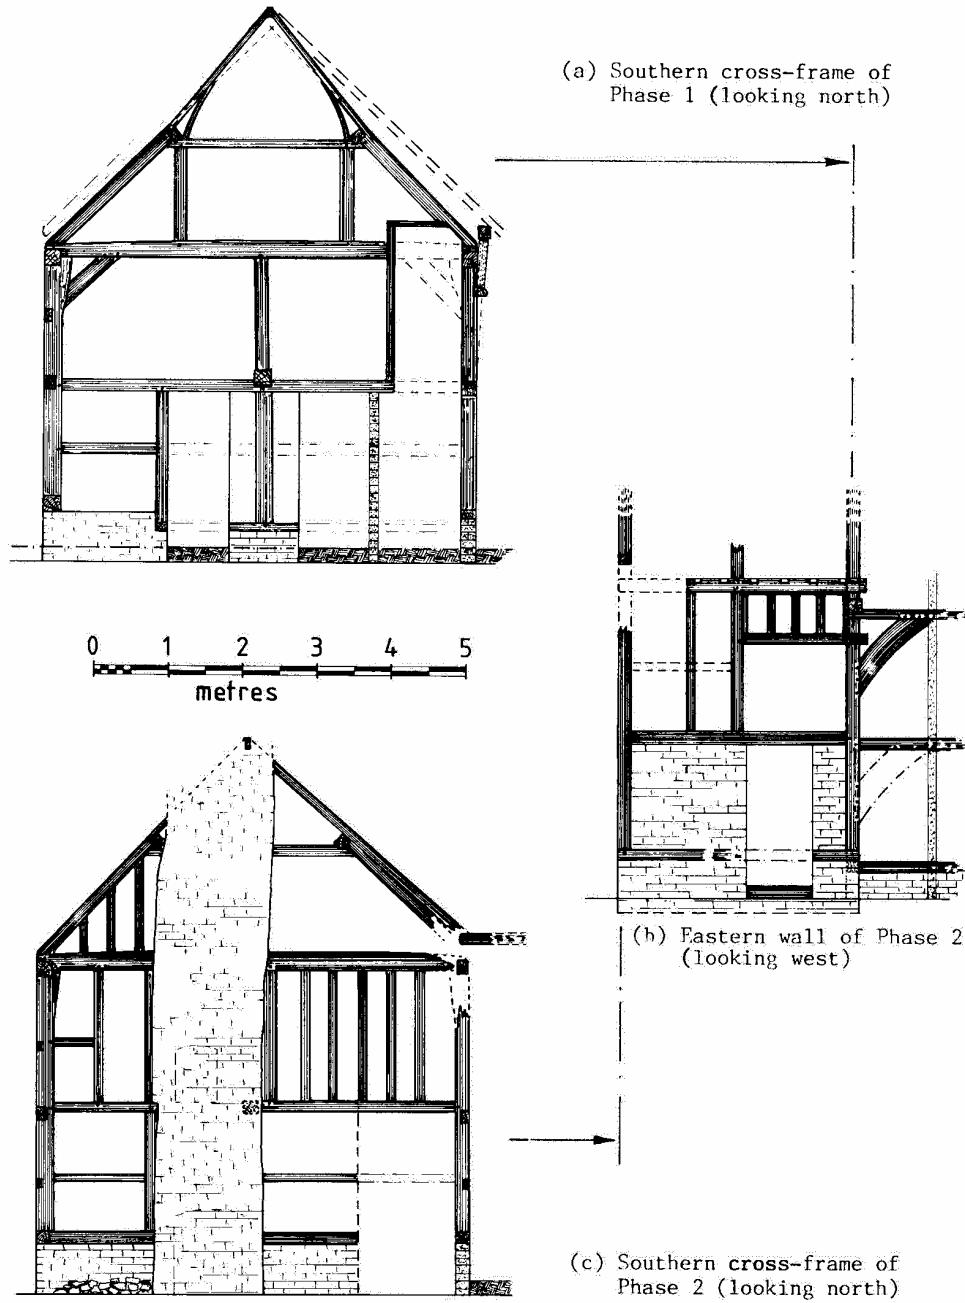
Figure 4 Structures in Phases 1 and 2

Windbraces consisting of 12" x 2" timbers can still be seen in various parts of the building - between wall post and tie beam on several of the cross frames, between post and both wall sill and girdling beam (the side timber supporting the upper floor) at the south-east corner (Figure 4 b), and between principal rafter and purlin in the north-west corner. It seems reasonable to infer that such braces occurred at all such points in the original structure.

The quality of the timber is generally poorer than for Phase 1. Only the south-west wall post remains, the top half of the other, at the south-east corner, having rotted away as a result of long-standing leakage from the roof valley above. These posts definitely do rest on the sill beams, which are mounted on base walls consisting of 4 courses of brick over rough chalkstone. They are rectangular in section (about 8" x 7"). The remaining jowl is of a different shape from those in Phase 1 (Figures 4a & c).

When Mr O'Hara stripped the upper part of the eastern wall, however, he uncovered a remaining window frame which is almost certainly contemporary with the original structure. It is built into the upper quarter of the wallframe immediately below the wall-plate (see Figures 4b and 6), and consists of three moulded mullions within a moulded frame. The mouldings are of almost symmetrical ovalo section (Figure 7). Centred within each bay of the window, a hole is drilled in both transom and sill, presumably as part of the arrangement used to retain the glazed panels. It is tempting to suggest that the panels may have pivoted around these sockets, but there is no evidence that such was the case.

It is possible that one of the other examples of violence being inflicted on the structure dates from this period. As shown in Figure 4a, a doorway has been installed in the southern cross frame of Phase 1 at upper floor level. This removed the windbrace, cut right

through the main tiebeam and removed half the depth of the principal rafter. Remarkably, this seems to have had no detectable effect on the stability of the house, as no relative movement seems to have occurred. The fact remains, however, that nothing other than the extended walls of Phase 3 now prevents the south-east corner of Phase 1 from collapsing outwards.

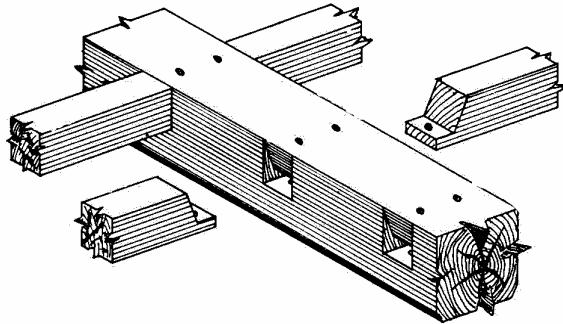
Figure 5 Soffit tenon joint between joist and bridging beam

Internally, the most notable feature remaining in the southern bay is the bridging beam, 9" square and 13' 3" long, with its inner end supported in the chimney breast. It is well chamfered, and the floor joists are jointed into it using a soffit tenon with diminished haunch as shown in Figure 5. This type of joint, described by Hewett (1980) as "the ultimate joist end joint", provides maximum mechanical efficiency and is dated by him from 1510 to the end of the seventeenth century.

The upper floor joists are again supported on a bridging beam, and again employ the soffit tenon with diminished haunch found in Phase 1 (Figure 5). The northern end of this bridging beam is halved and tenoned around and into the central upright post of southern cross-frame of Phase 1, while the southern end is buried in the brick chimney. This chimney, with fireplaces on both floors, seems to be a much later addition and - along with the brick infill in the eastern wall may date from the Victorian rebuilding.

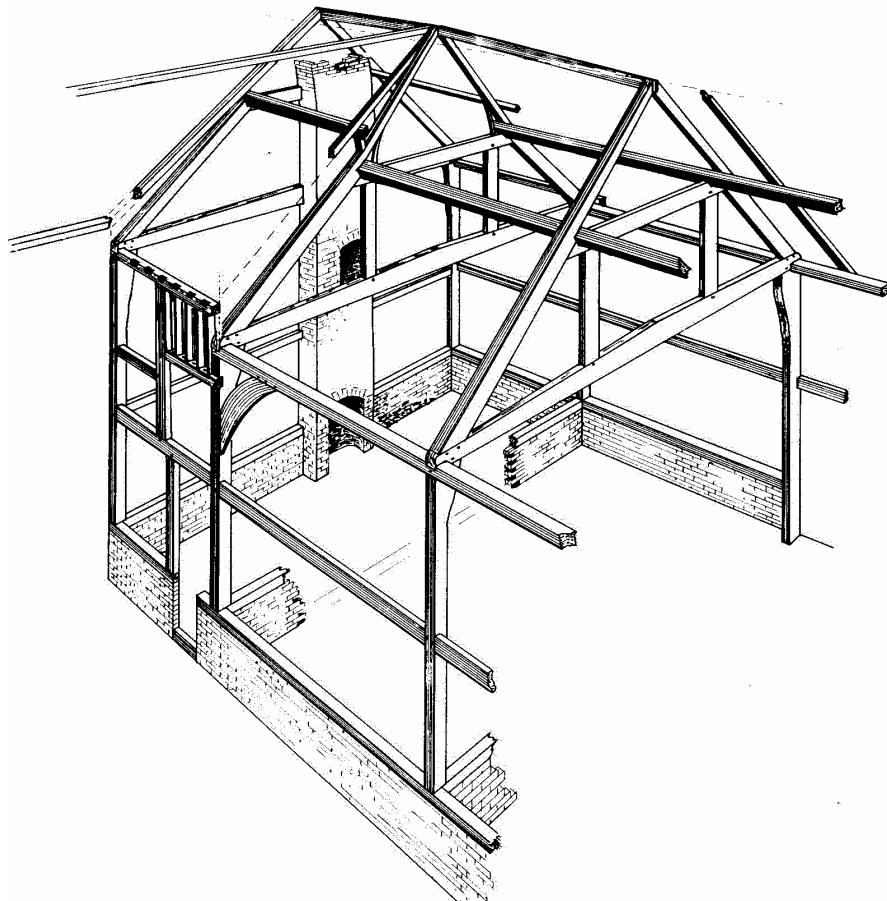
The next major phase of building consisted of the addition of a further bay on the southern end. This bay has a tapered plan, clearly built to conform to the boundaries of the site. Its relationship with Phase 1 is shown in Figure 6.

Figure 6 The relationship between Phases 1 & 2 (looking towards the south-west)

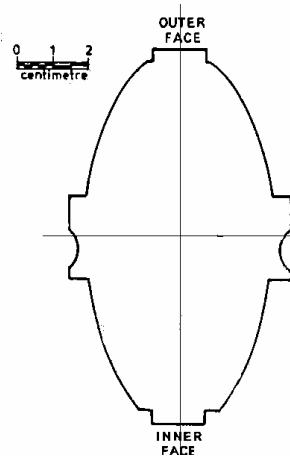
Figure 7 Ovalo moulding

The shape of the mouldings and the general proportions of the window point to a date not earlier than the late sixteenth century and, bearing in mind that rural development usually lagged behind that of cities, probably mid-seventeenth century.

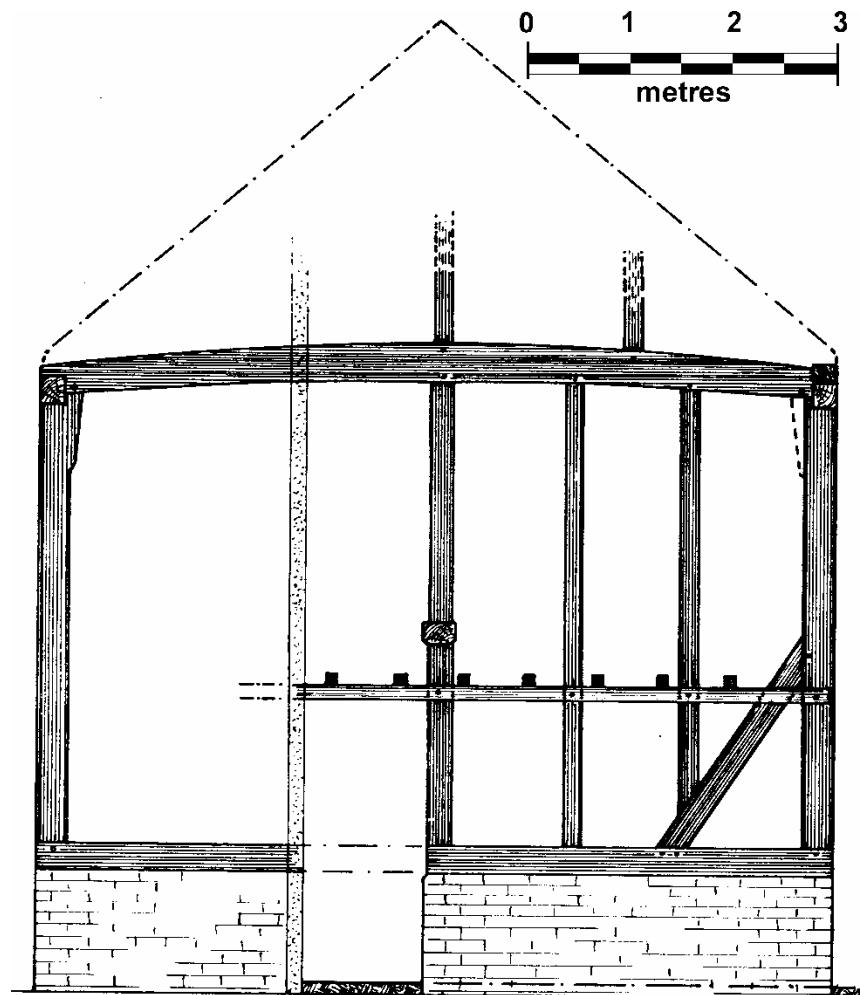
The wall frames again stand on chalkstone walls, 2' 9" high and 12" thick, but the carpentry is much rougher. Except for the tie beams (6" thick and 13" deep in the centre, tapering to 7" deep at the corners), the sills and wall-plates, there are no horizontal timbers in the structure, all the framing being vertical (Figure 8). The southern wall, which was the only one exposed to view during this survey, was covered on the outside with horizontal weatherboards 15-18" deep (see Figure 2). At a later date, these were in turn covered externally with lathe and plaster. This part of the building now possesses an upper floor, but was probably open to the roof when built. The bridging beam is not tenoned into the cross-frames but rests on samson posts fitted to the central upright members of the cross-frames.

Figure 8 Western cross-frame of Phase 3 (looking east)

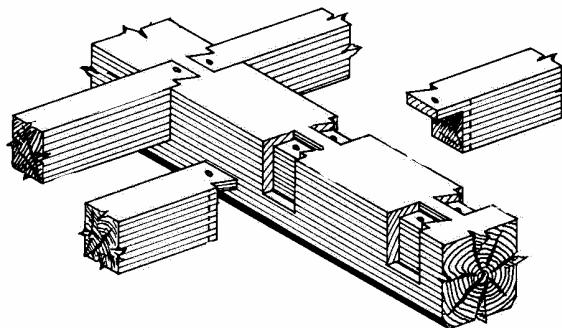
At a later stage again, as already mentioned, an upper floor was inserted. In this case, the joist end joint differs from that used in Phases 1 and 2. It used a face-lapped half dovetail with housed shoulders (Figure 9), which is at first sight a more sophisticated joint than the soffit-tenon type used in the other phases. In fact, it is mechanically much inferior to the joint shown in Figure 5, as it removes compression timber from the bridging beam and gives little support to the joist if shrinkage should occur. It is, however, less labour-intensive as it is much quicker to cut and so represents a common progression in jointing techniques.

Figure 9 Half-dovetail joist joint in Phase 3

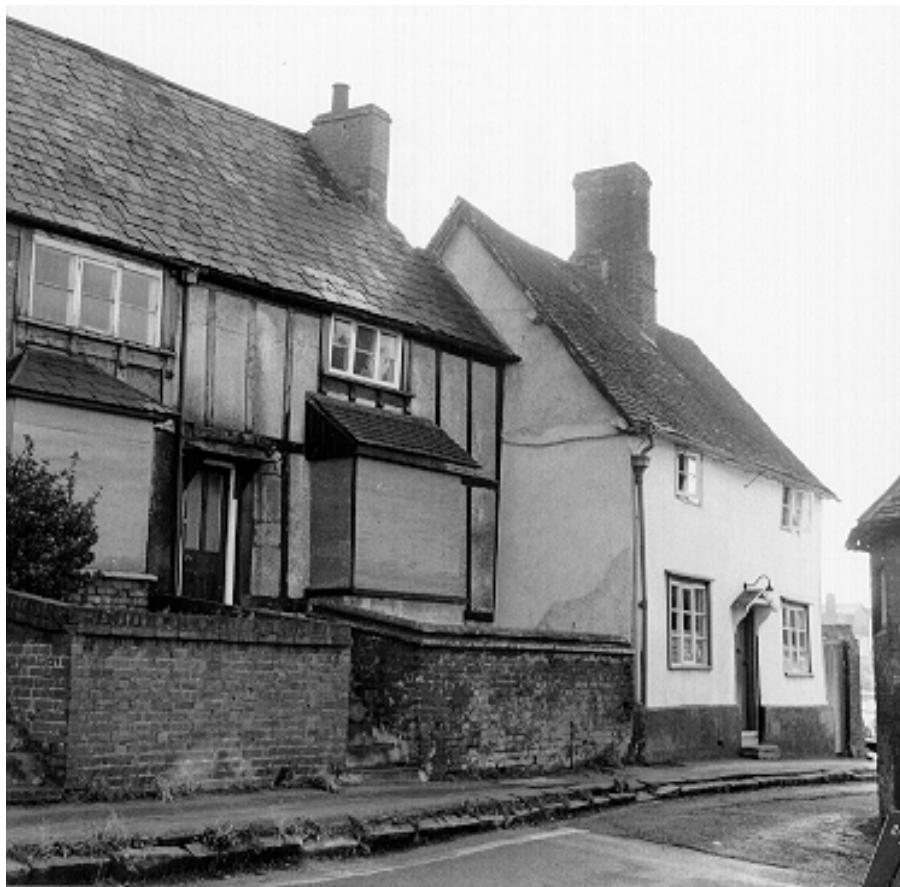
Wantage Grove Street - 1960s? - Nos.34, 32 (renovated 1975), and 30 (16th C, was "Rose & Crown"). (Surveyed J Garnish 1982) (st070.jpg)

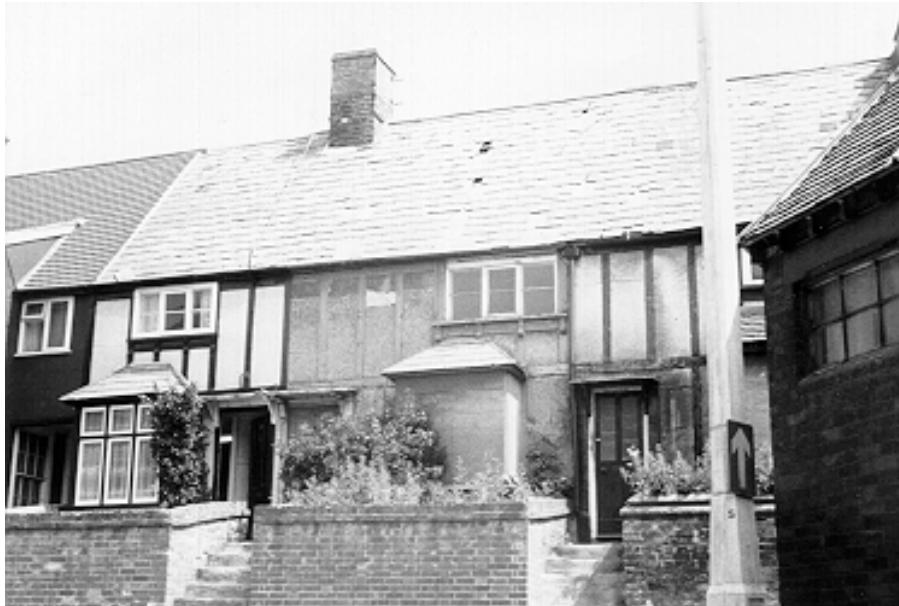
Wantage Grove Street - 1976 - Nos.32, 34, 36
1931 - No.32 L Parkin, No.34 E E Rolls, No.36 F W Rolls
1924 - exors. James Welch, town crier, toll collector, bill poster. (st073.jpg)
